# Premium Home Inspection

## CONFIDENTIAL INSPECTION REPORT

3526 E Apple Ct, Yourtown, Az. 85044

06/02/2006 2:00 pm

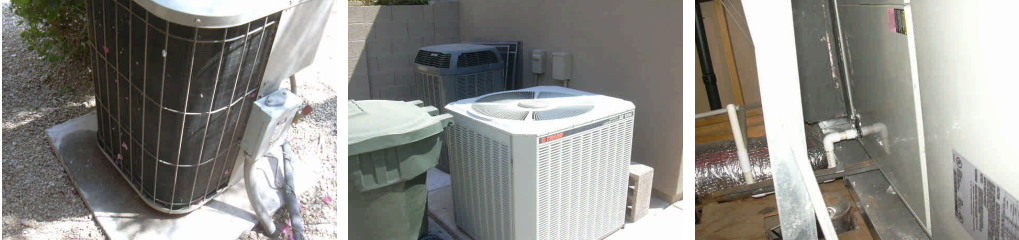
Central heat and air-conditioning is provided by three mid aged heat pumps, that are located in the side yards, with a air-handler located in the attic and in the garage and in the lower closet. They responded to the request for cooling, but were not tested on the heat cycle because the ambient temperature is too high and to do so could have damaged the coils.

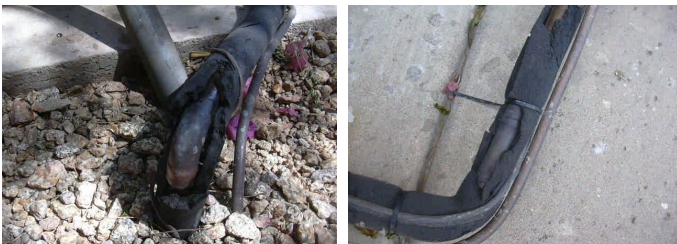
Insulation is deteriorating from the refrigerant lines at the condensing coils and should be replaced. 3x
